# M100

## 5MHz Upgrade

Version 1.1

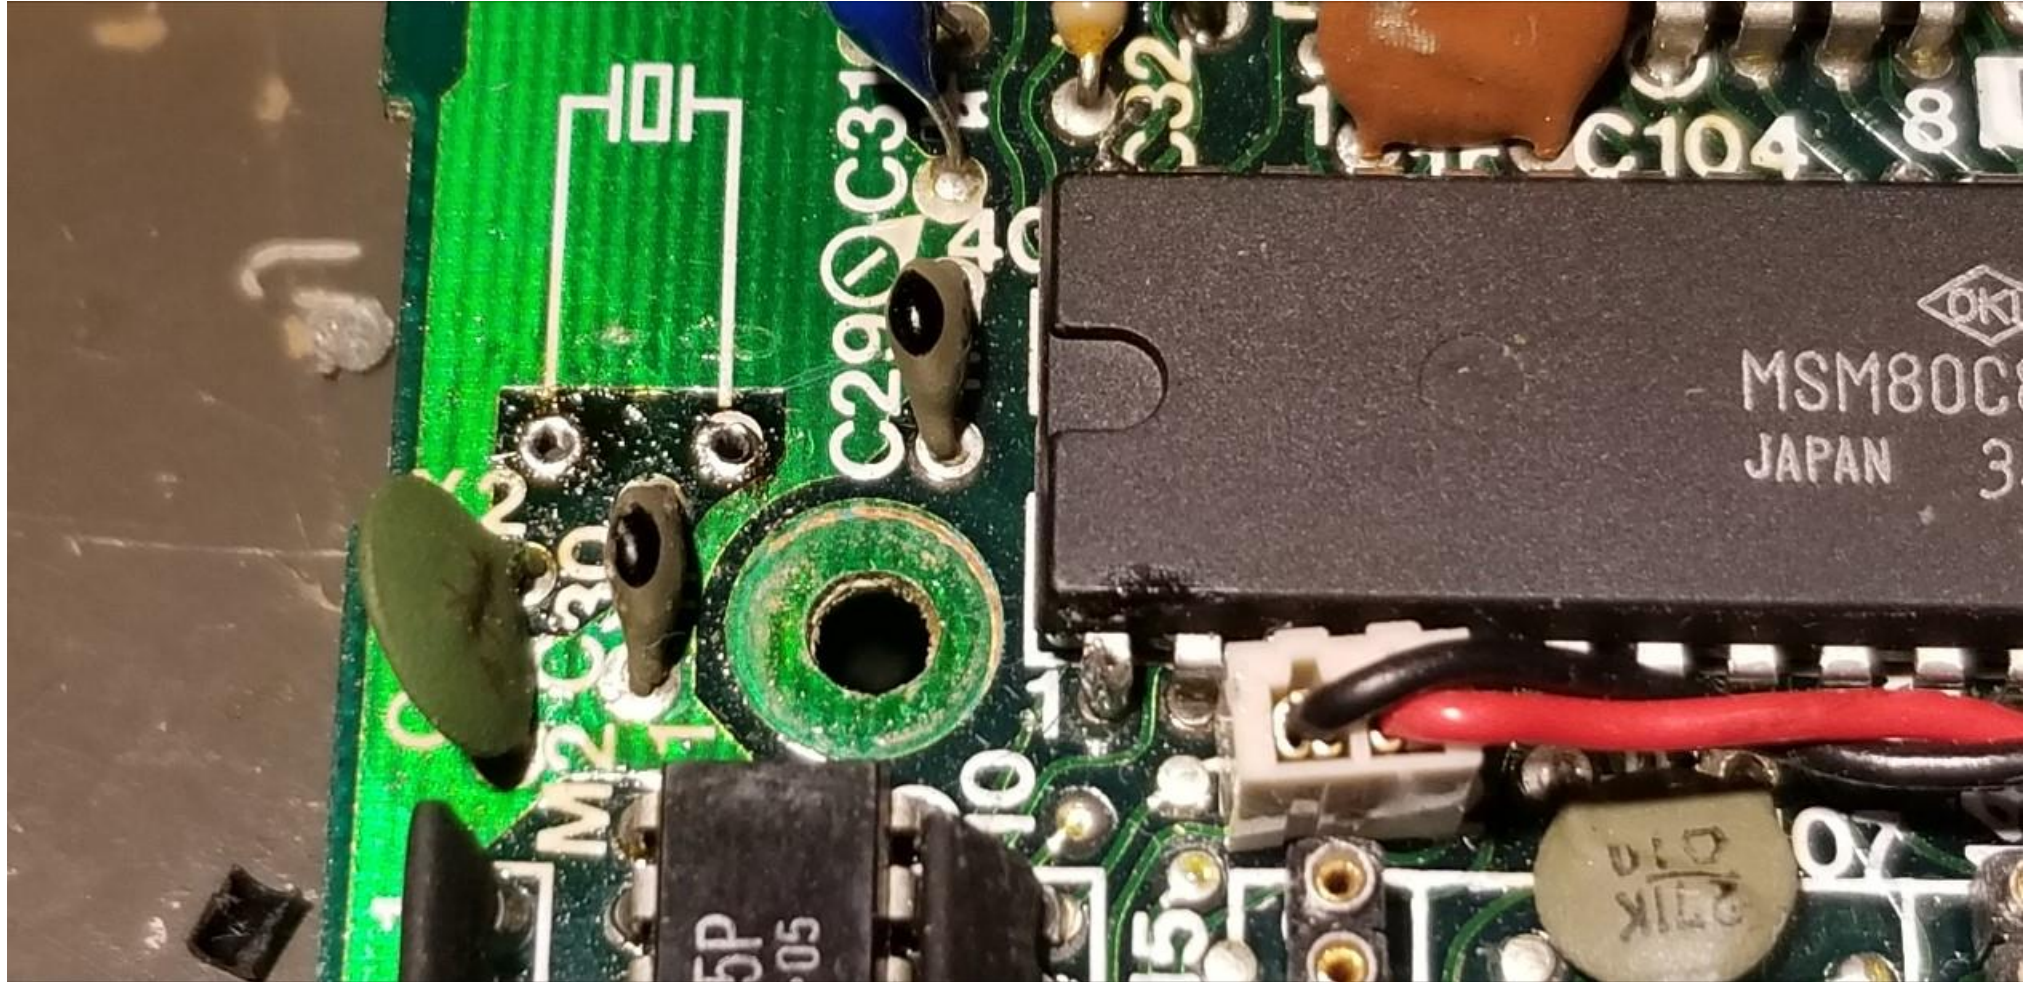
Remove the original 4.9152MHz crystal

Remove the M100 PCB from the case. Using whatever means, remove the crystal and clean out the vias. Save crystal if you want to revert.

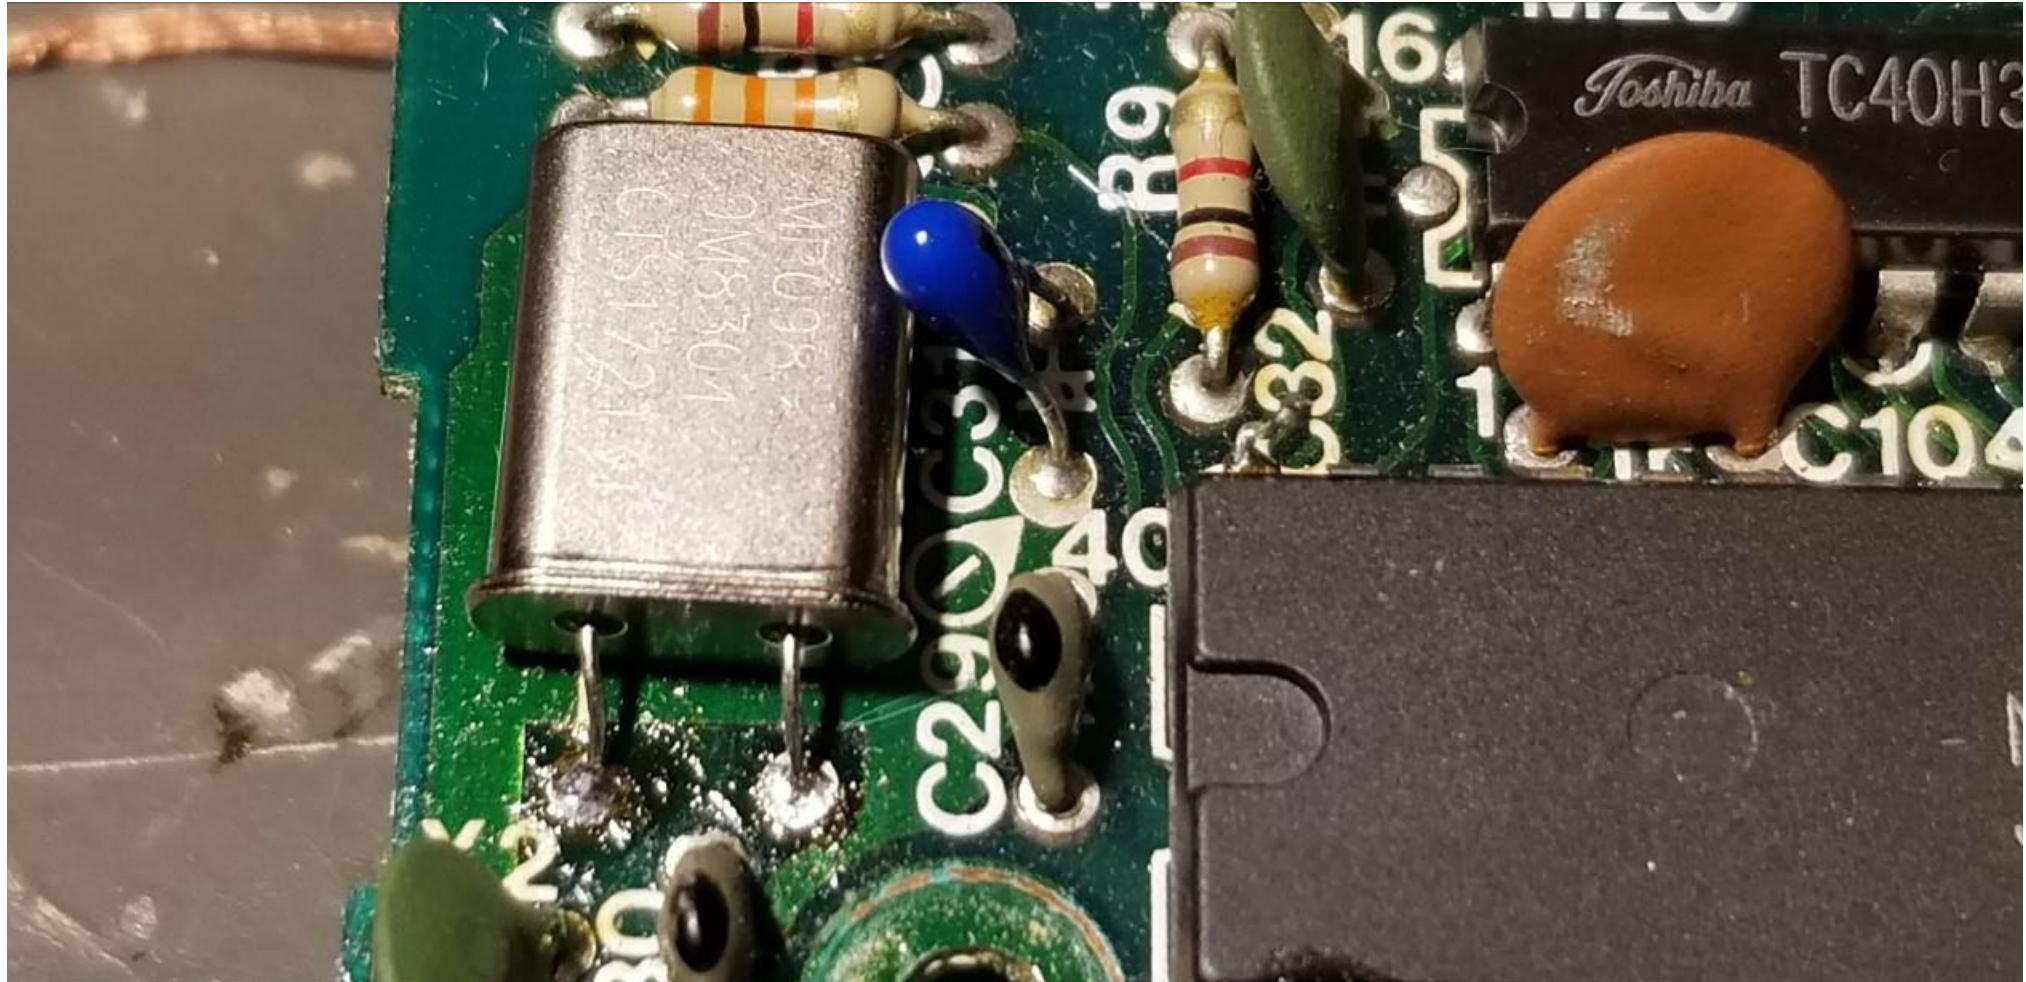
Install the 9.8304 MHz crystal

Insert, solder, trim the leads

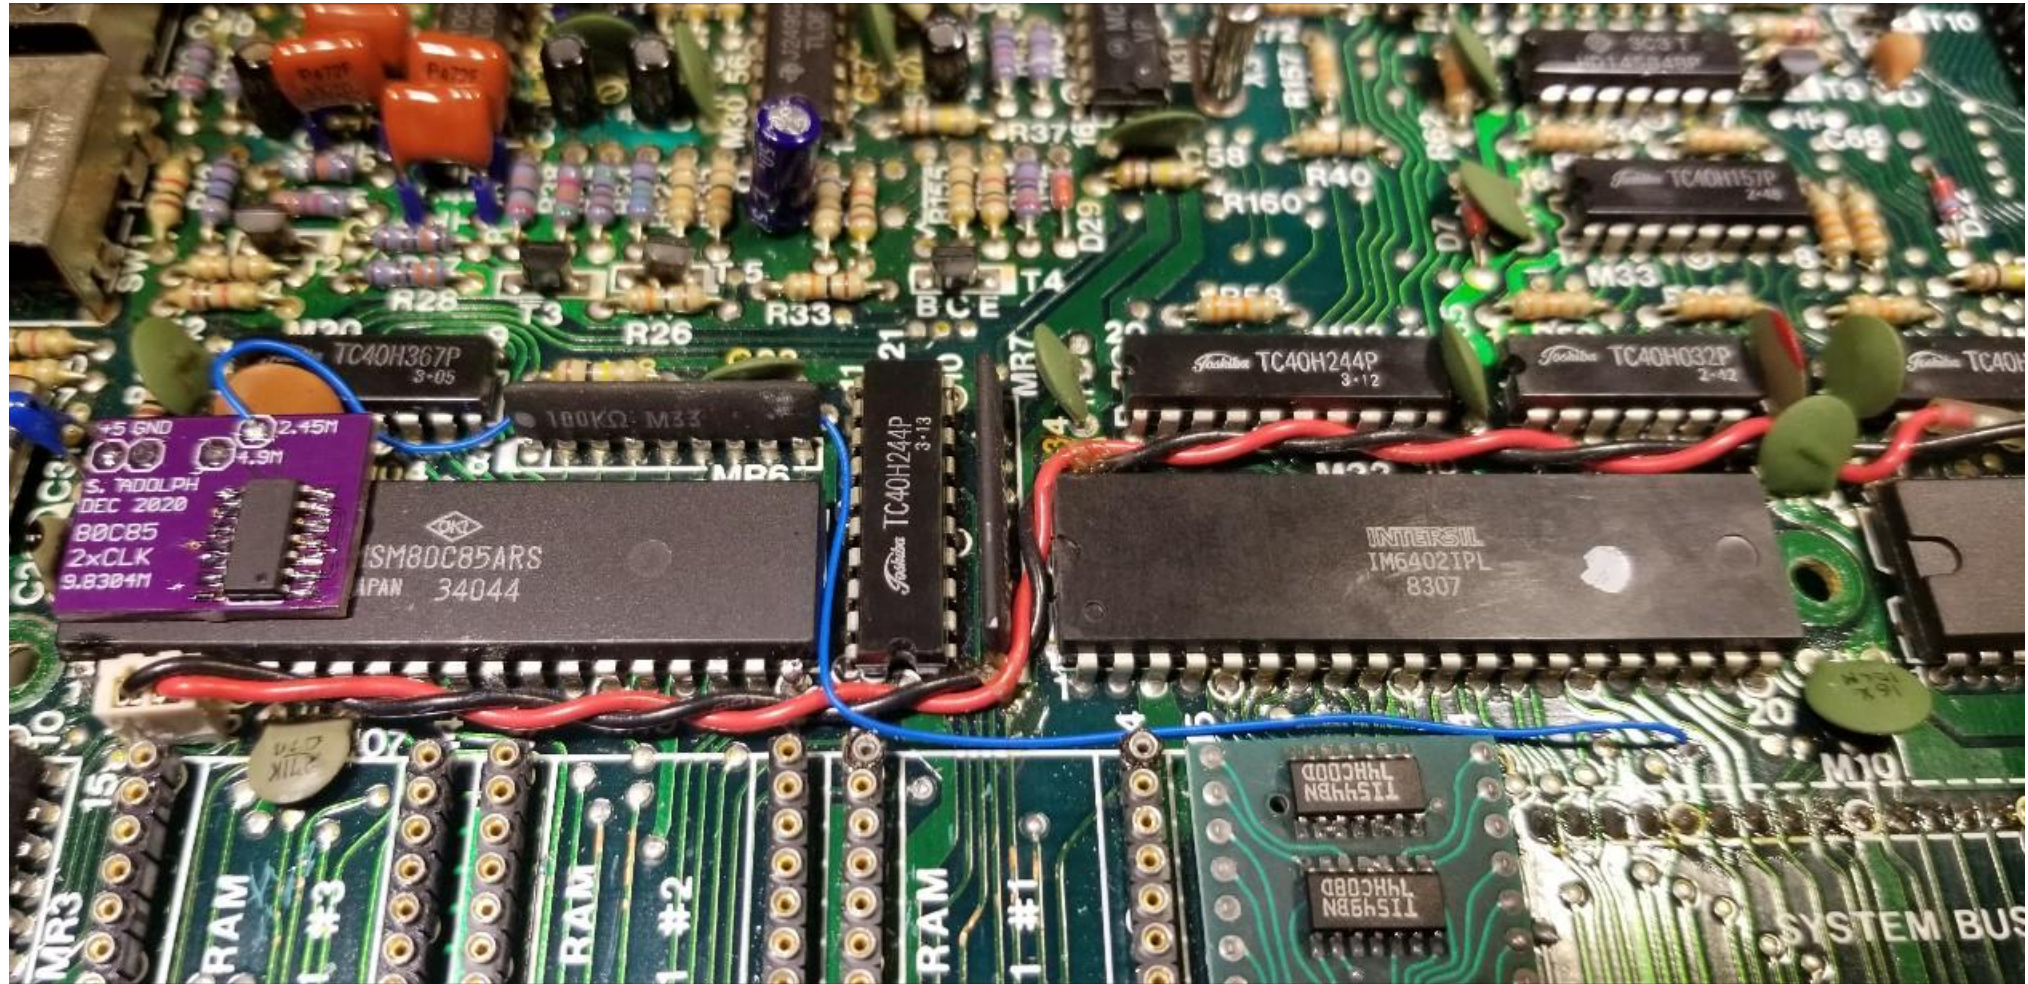
# Connect new clock signal

Run a wire from the via right next to the clock track cut, to the 2.45M pin on the clock divider PCB.

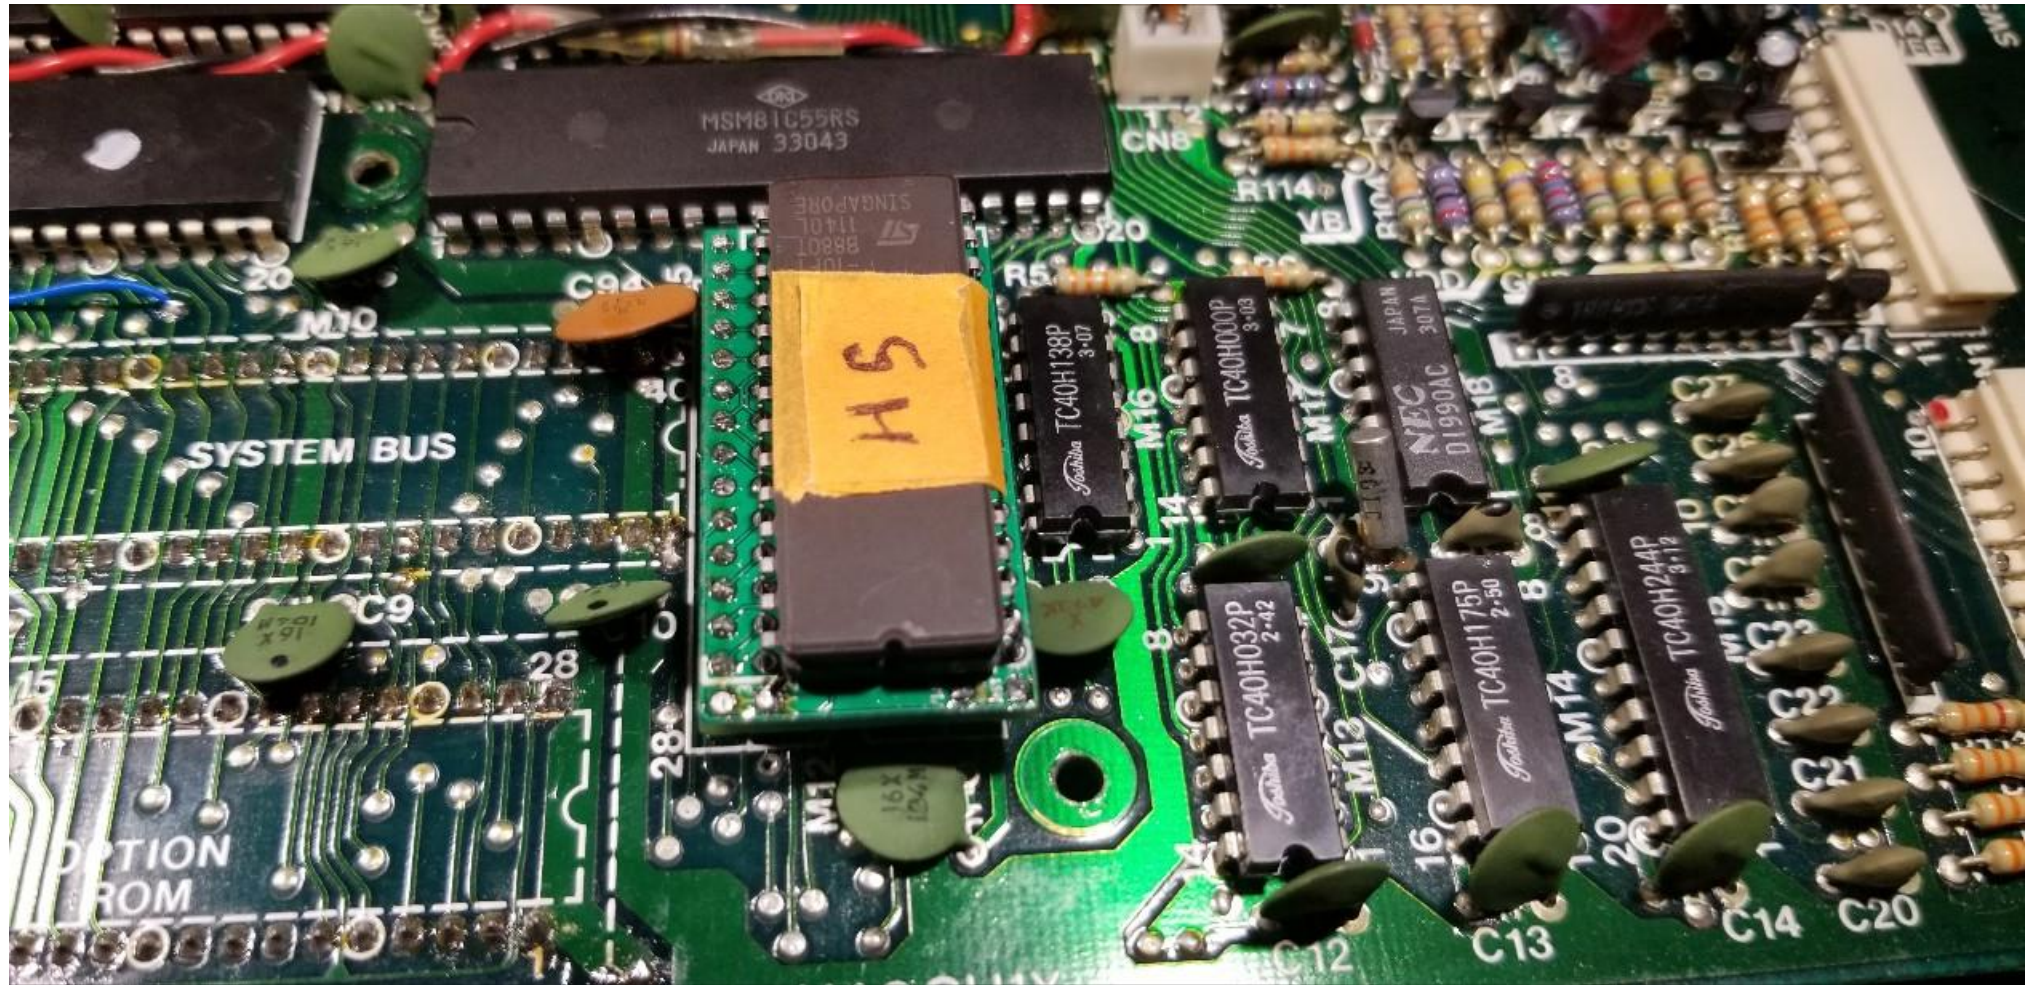
# Install faster Main ROM

Install new Main ROM using adapter. Use an EPROM that is 150nsec or faster. Image can be stock, or modified to suit. I'm using the hardware scroll patch.

The SHARP LH535618 main ROM is rated at 600 nsec. I've tested several and about 30% of them can actually run at 5MHz. But most do not.

Mounting a modern, fast (<200nsec) EPROM requires an adapter board, which you will have to assemble or buy.

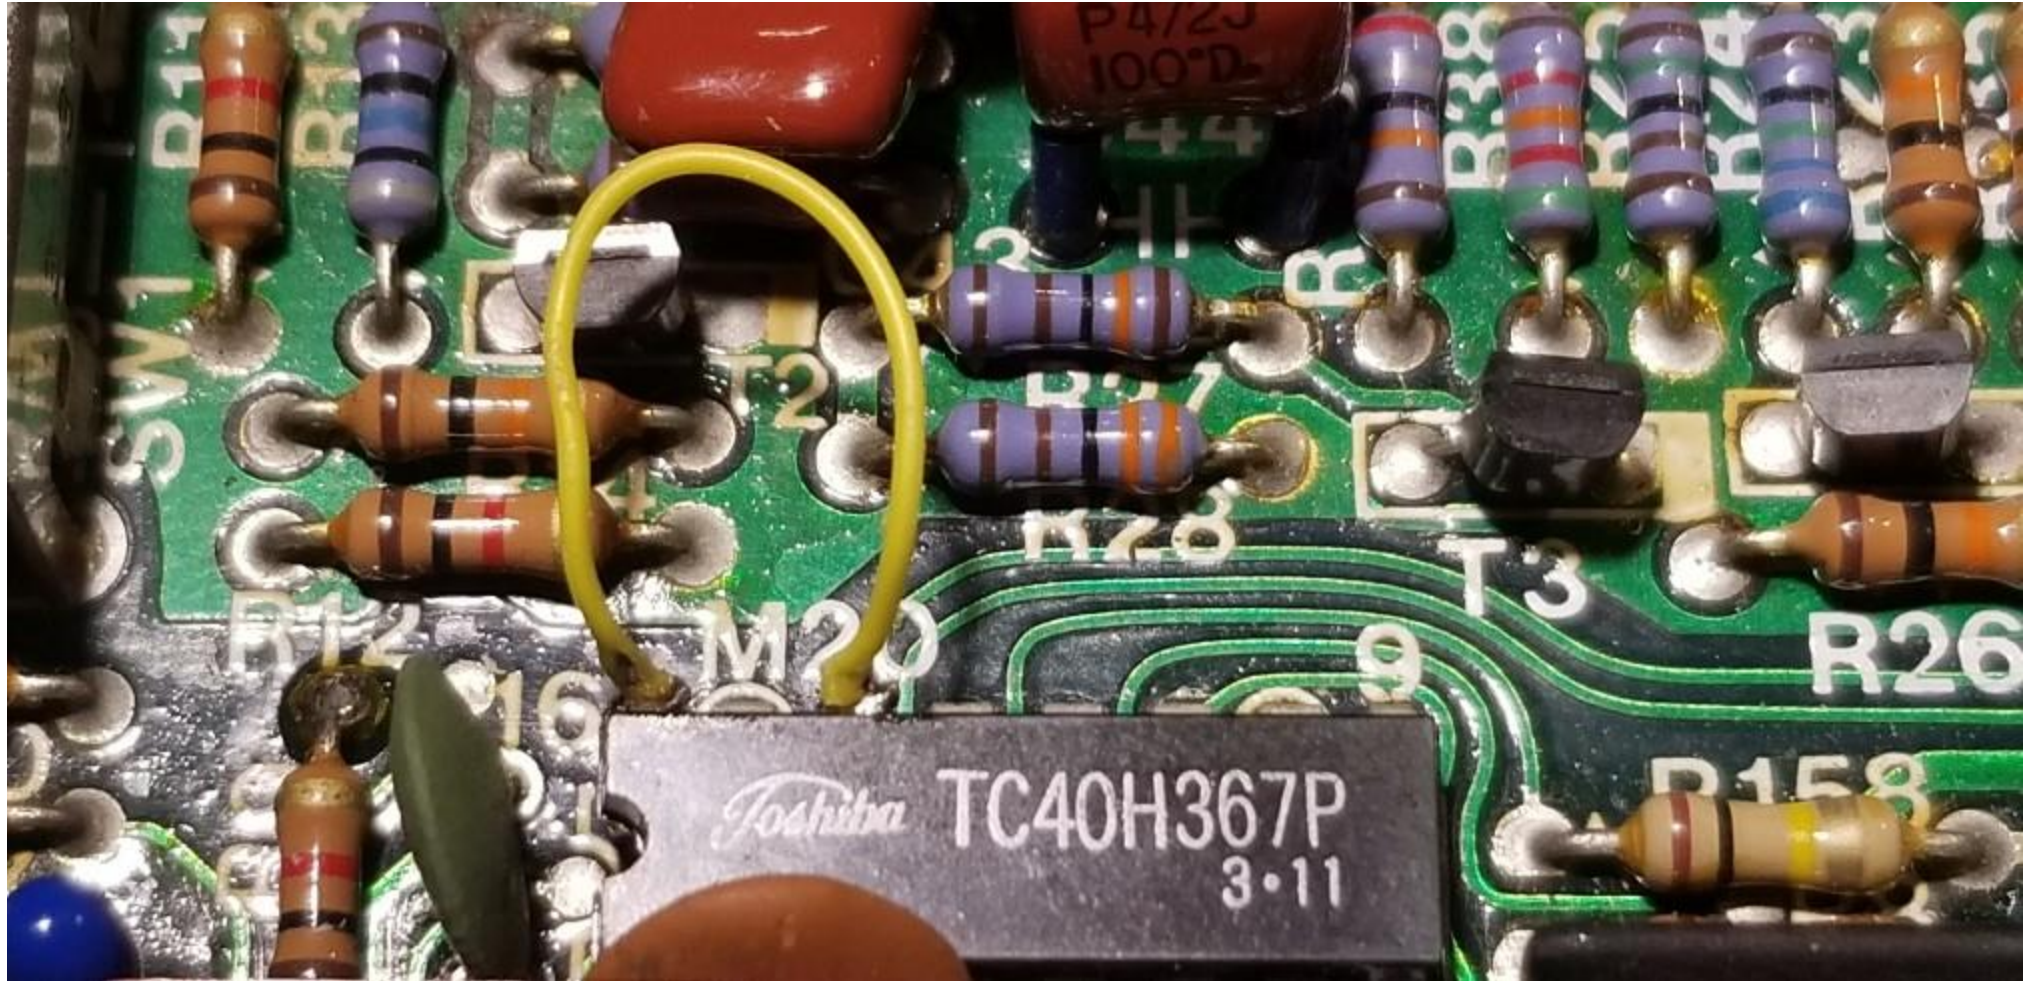
Faster SRAM: Pull A\* buffer input high

Solder a short wire from pin 16 to pin 14 of M20. This drives A\* high to the chip select circuits, which in turn speeds up the access to the SRAM.
